# TEST REPORT

**REPORT NO.** : D270-16-00037-1

**ITEM** : HANSTONE

**01. CONTAMINATION RESISTANCE ( JIS K 6902 : 2007 ) : RATING**

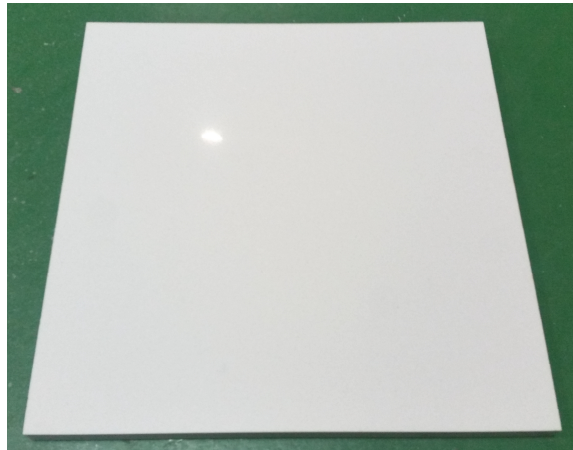
- SAMPLE PHOTO -

**DESCRIPTION :** ONE(1) PIECE OF SUBMITTED CUTTING SAID TO BE TILE

#1
SHOE POLISH	RATING 3
INK	RATING 3
